# NEILLY GROUP ENGINEERING

IRVINEBANK WATERSHED RESTORATION PROJECT  
INVESTIGATION AND PRELIMINARY  
REHABILITATION PROGRAM

15 AUGUST 2022

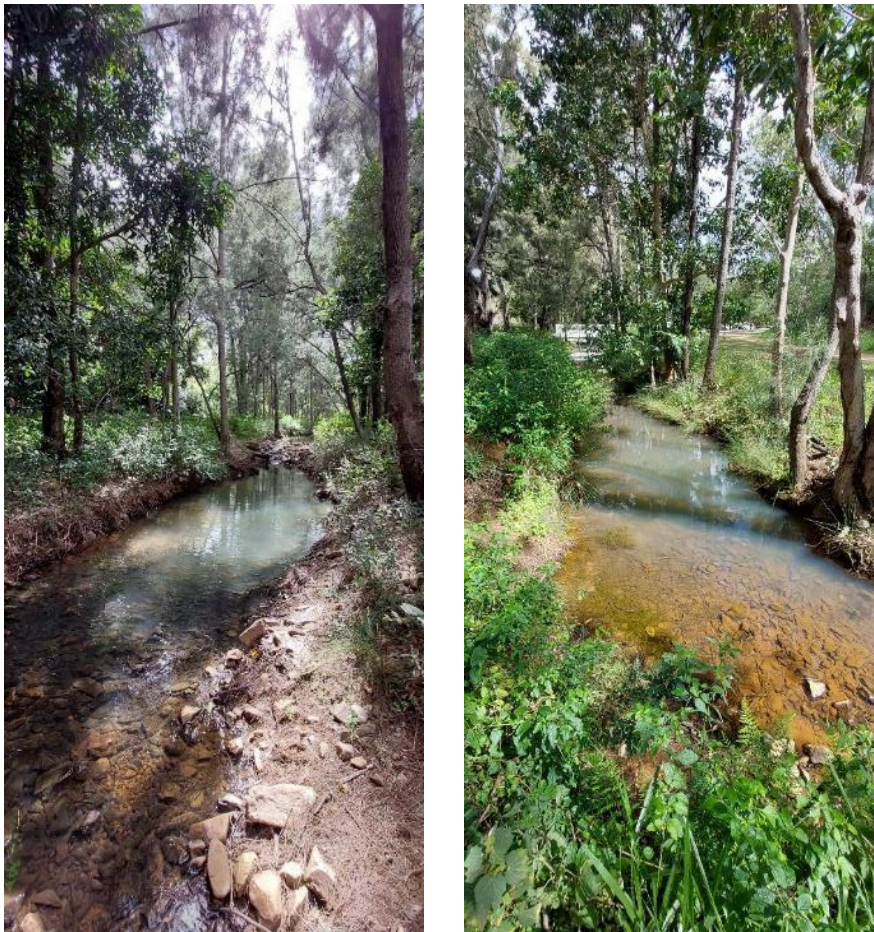
**Figure 11 Example of existing pool-riffle feature upstream of bridge (left) and bed sediment accumulation (right) – photos courtesy of Jim Tait**

The channel running directly through the centre of town exists as a series of pool-riffle sequences through a cobble substrate (Figure 11). Inspection of the reach shows that bed sediment has accumulated throughout the reach (Figure 11). The overbank area has been colonised by thick vegetation which, in areas, consists of weedy vegetation. Throughout a section in the centre of town, the overbank consists of parkland with mature fig trees present (Figure 3, page 11).

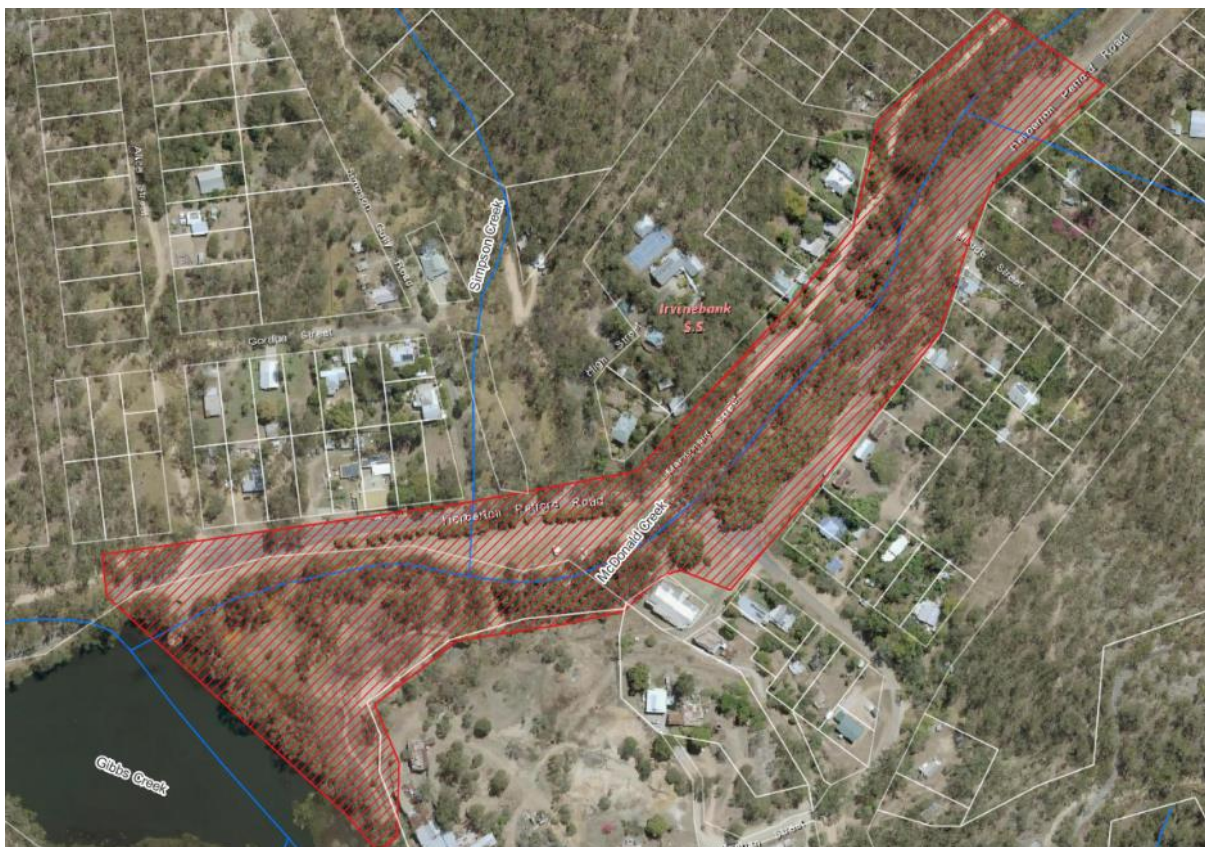
**Figure 18 Area required for survey acquisition for Detailed Design**

Updated topographic information will be required for the area outlined below in Figure 18. This is an area of approximately 6.6ha which will require topographic and feature survey. Estimated cost for this area is approx. \$15,000 for a licenced surveyor to undertake these works based on previous NGE projects.

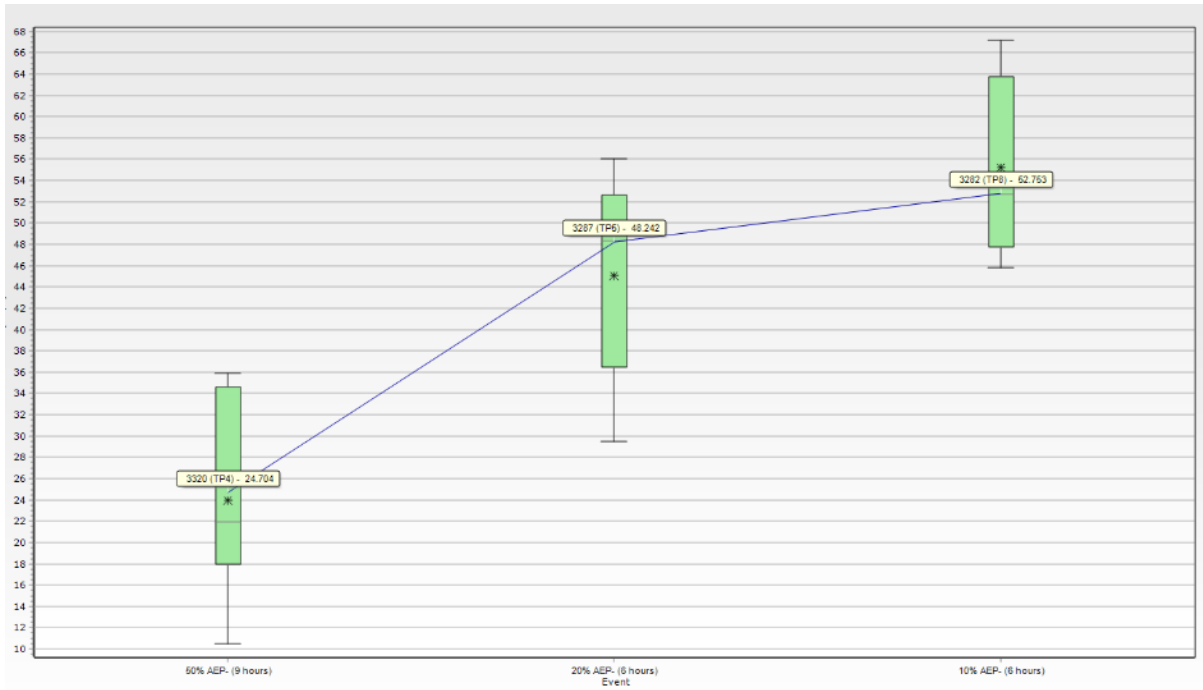
Figure 26 Adopted peak flow rates for McDonald Creek immediately upstream of the bridge

For the purposes of modelling expedience, the critical duration storm for Simpson Creek was adopted as the same critical duration for McDonald Creek, as the only difference is the temporal pattern chosen between the two. This ensures that the same TUFLOW model run can be examined for McDonald Creek and Simpson Creek, rather than a separate run. This results in an adoption of a peak discharge of 1.5m<sup>3</sup>/s for Simpson Creek (TP04) instead of a peak discharge of 1.85m<sup>3</sup>/s (TP02) for the 50% AEP.

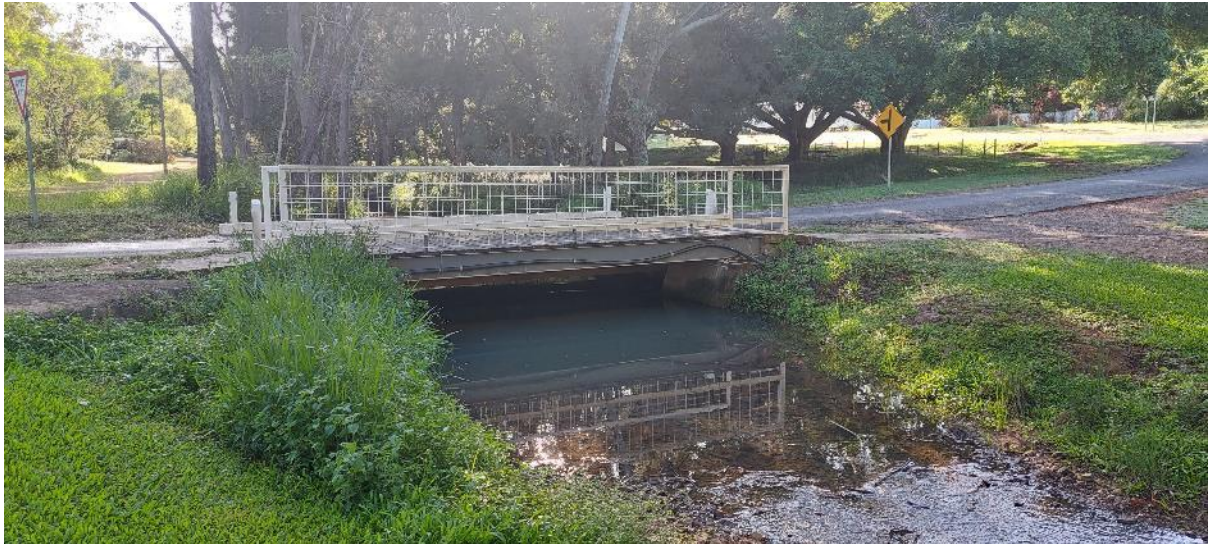
Constricted scour pool beneath existing MacDonalds Ck bridge – currently used for swimming recreation. Emulation of flow constriction – scouring pool formation proposed for upstream reach

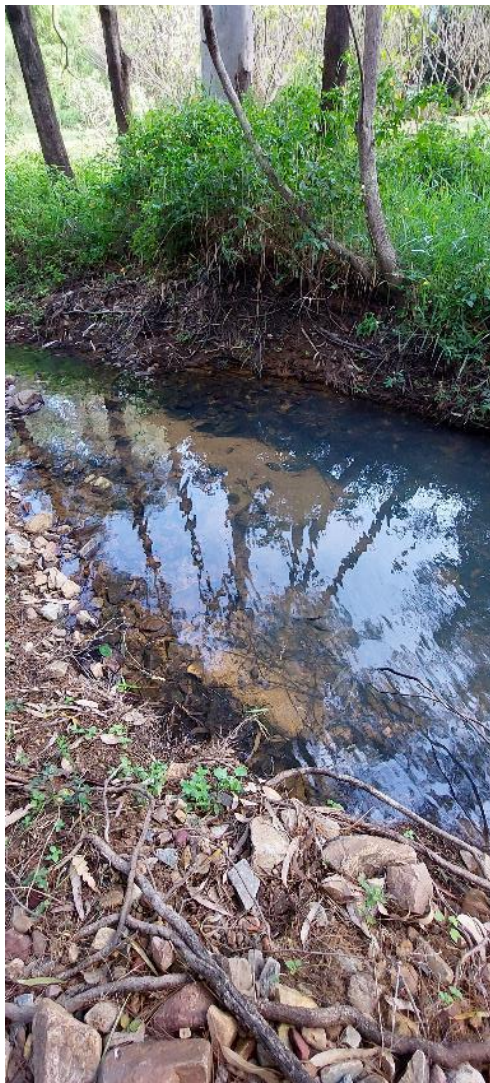
Example of existing wading pool within riffle – scour pool sequence reach upstream of bridge.

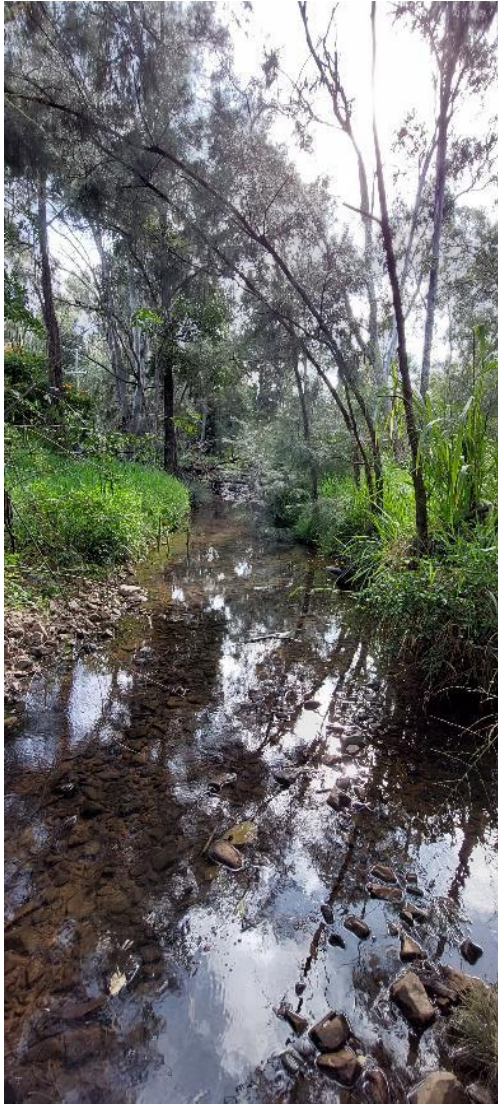
Accumulated coarse material within stream channel upstream of bridge, Size fraction of this material means only likely to mobilise on extra large events

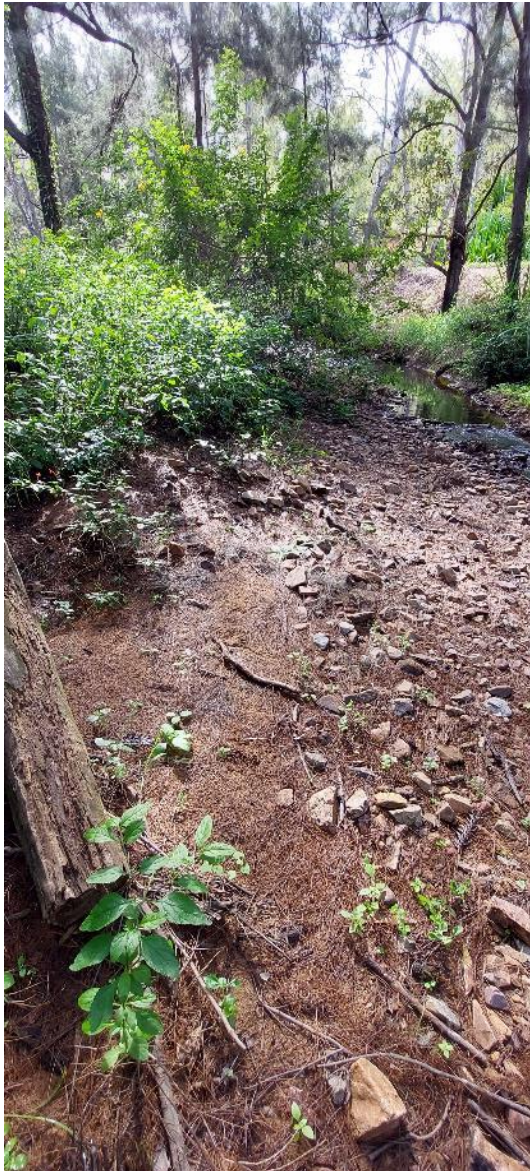
Bed accumulated sediment at top of riffle- scour pool reach above bridge, a potential source of sediment bed load during large events

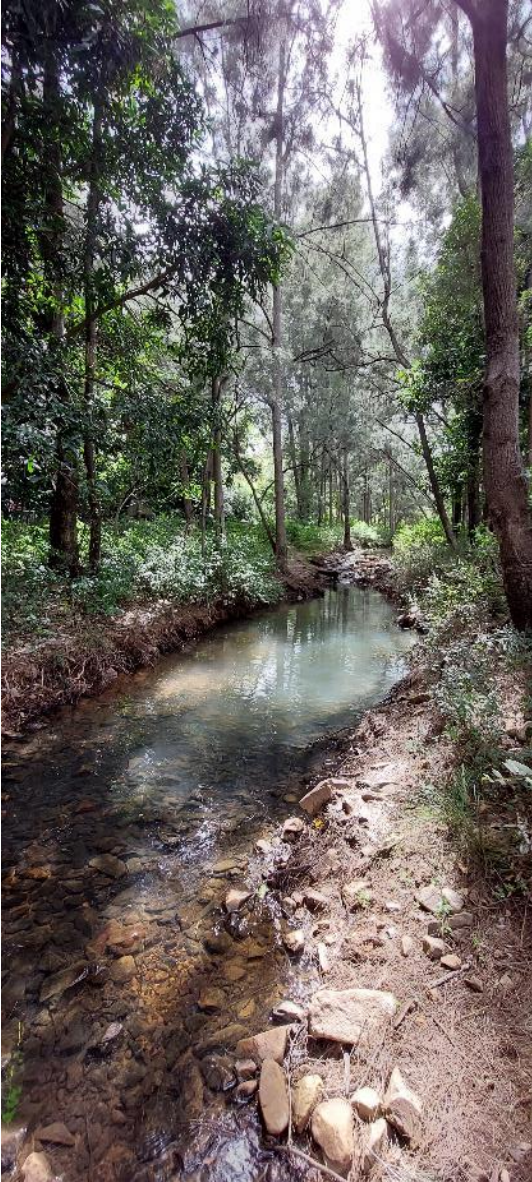
Example of existing pool feature in riffle -scour pool sequence reach upstream of bridge. The intention is to emulate and accentuate this channel form with proposed works

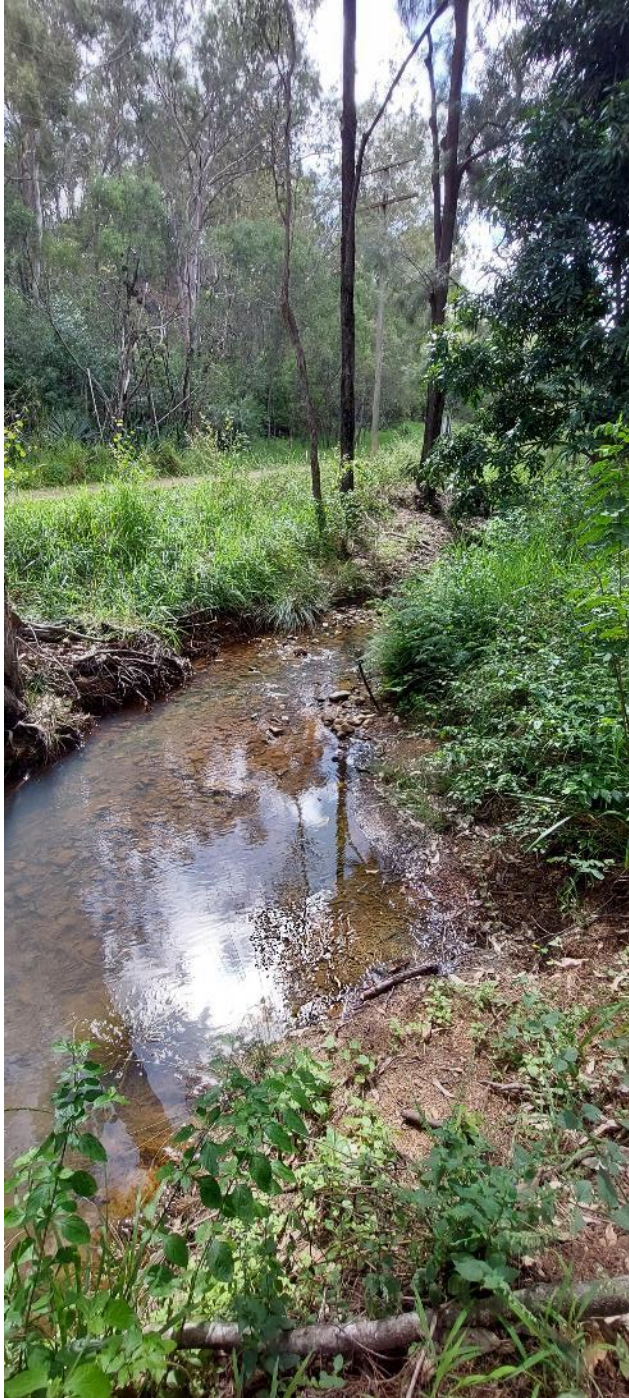
Accumulated bed sediment in reach above bridge, a target for extraction and channel capacity reinstatement . Road frontage in background currently experiences flooding when the stream breaks our of the sediment filled channel.

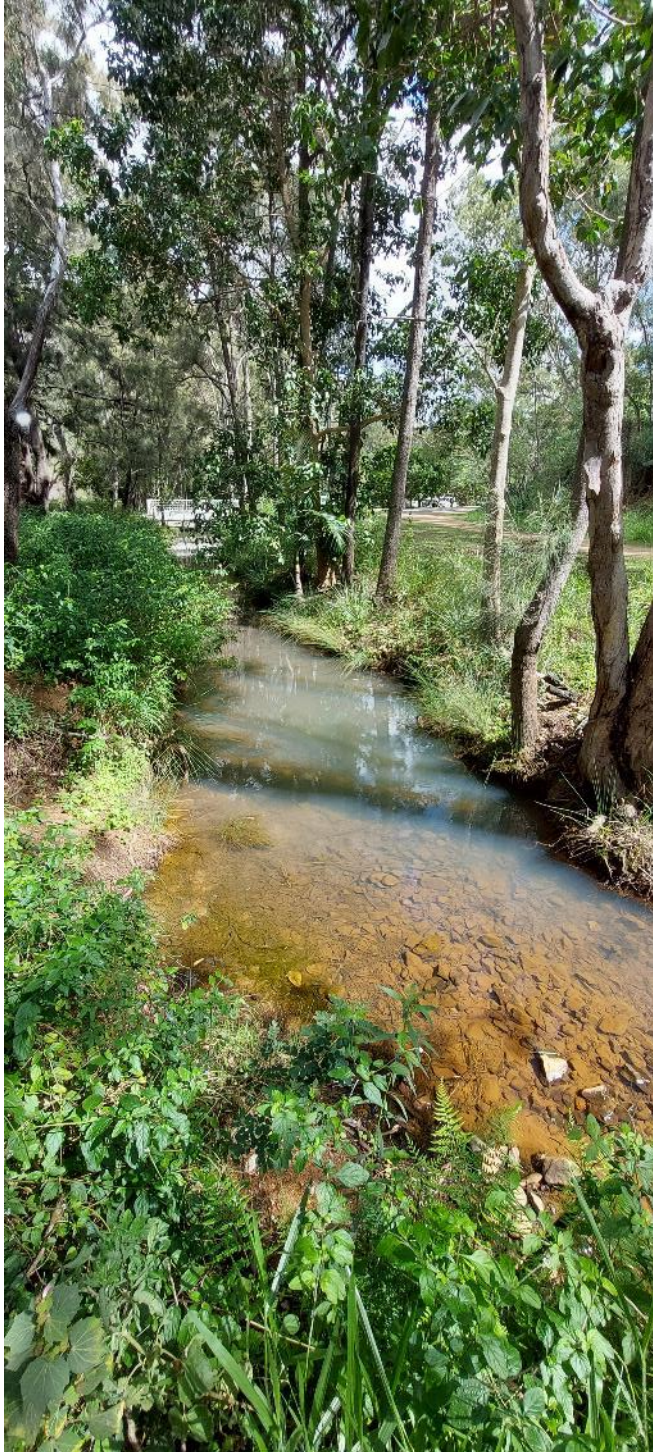
Accumulated bed sediment in reach above bridge, a target for extraction and channel capacity reinstatement – bank forming and weed clearing proposed for left bank

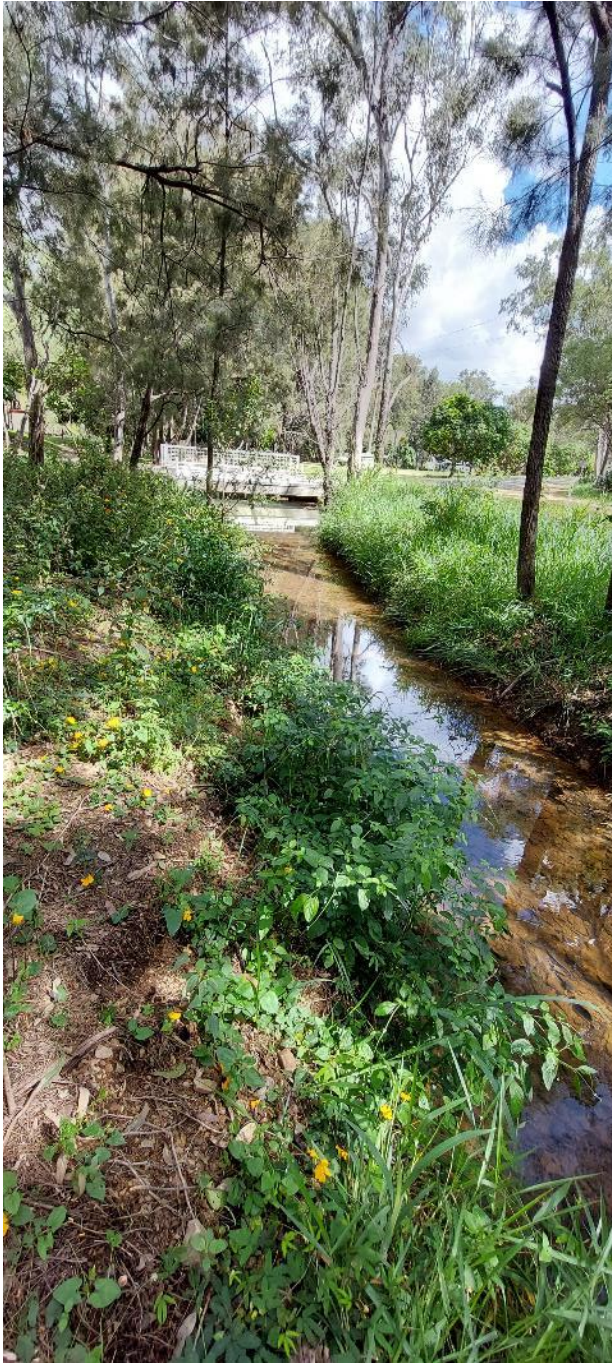
Accumulated bed sediment in reach above bridge, a target for extraction and channel capacity reinstatement – bank forming and weed clearing proposed for left bank

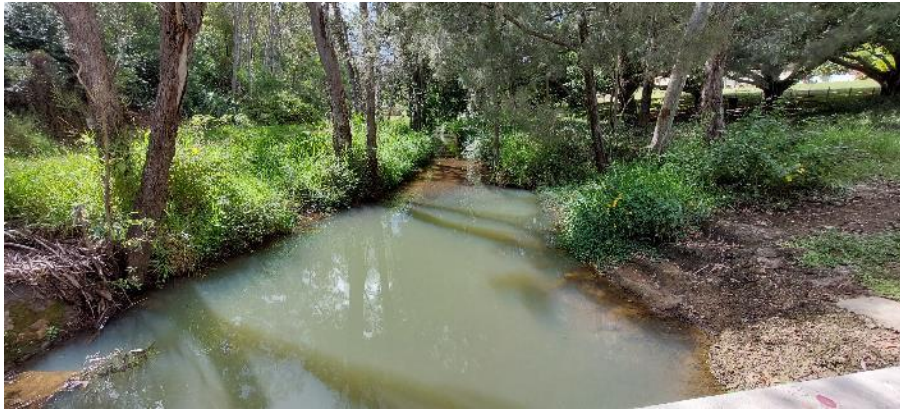
Prograding bed sediment load at top of pool formed around bridge constriction, target for extraction, or possibly suitable extraction point for a sediment trap – right bank proposed for weed management

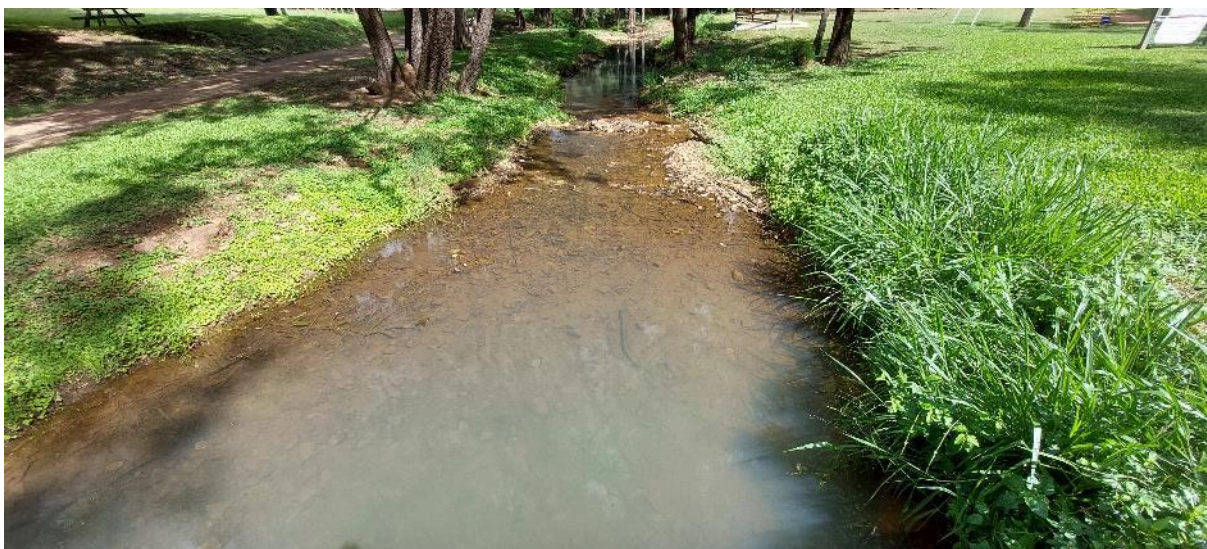
Accumulated bed sediment downstream of the bridge constriction scour – maintaining a straight flow path conduit downstream and some channel proposed pool feature separation (rock wall?) on right bank of existing channel could protect proposed expansive pool feature (right) from sediment inflows

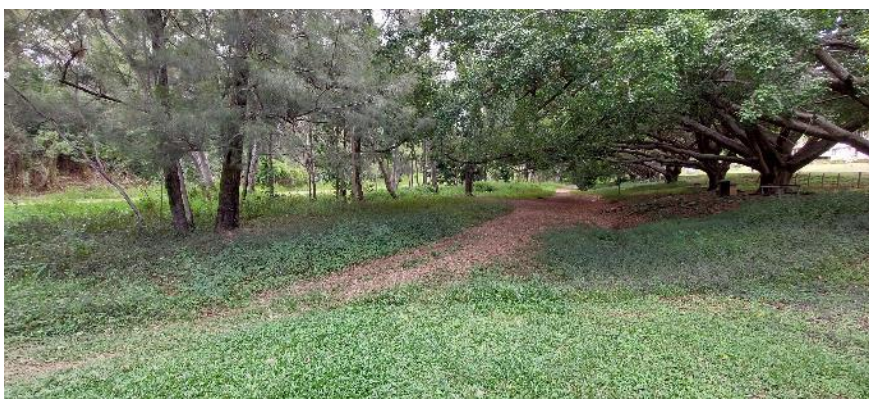
Fig tree canopy reach upstream of bridge is proposed for sediment extraction channel reinstatement and wading dipping pool amenity formed by accentuation of in channel scour pool and riffle sequence by large rock flow constrictions in-stream channel – NB need in channel controls to limit change in slope between works reach and upstream sediment stores to prevent bed coarse material stores being stabilised

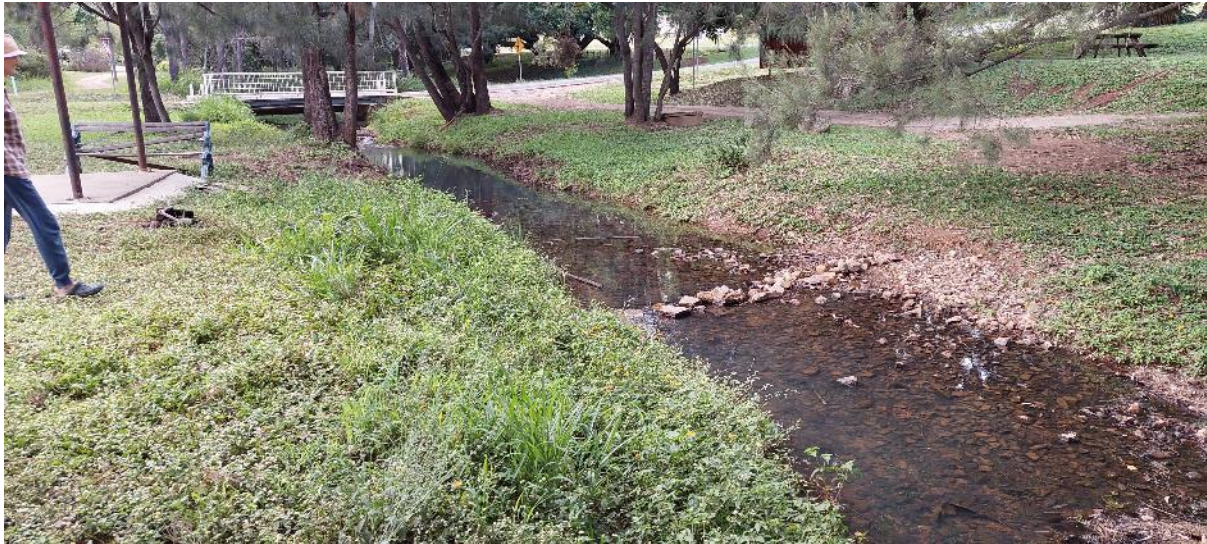
Proposed swimming pool feature would lie to left in front of upstream bridge crossing. Protection and stabilisation of bridge infrastructure under high flow events needs to inform pool design.

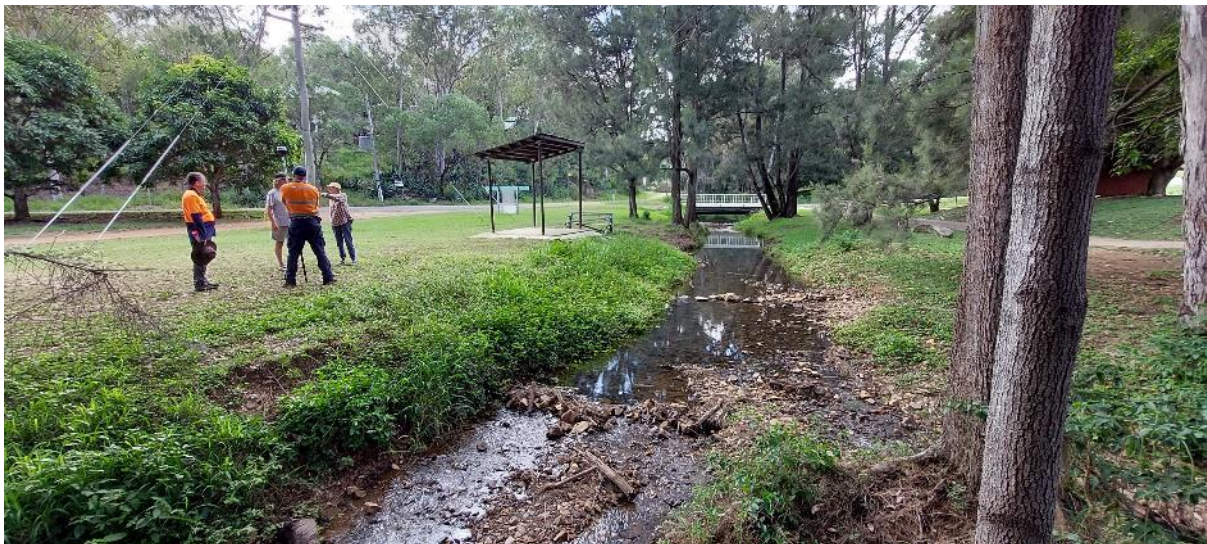
Proposed preferential flow path for Simpson Ck catchment inflows may have confluence with main stream channel in foreground left
